REGION 5 Enforcement Division FIELD NOTES

Inspection Date(s):	05/17/2022 - 05/17/2022	Announced: No			
Time:	Entry: 08:00 AM (CT)	Exit: 02:10 PM (CT)			
Program:	RCRA				
Regulatory Program(s):	Title 40 - ENVIRONMENTAL P REGULATIONS	Title 40 - ENVIRONMENTAL PROTECTION AGENCY; ILLINOIS STATE REGULATIONS			
If Access is Denied:					
Company Name:					
Facility or Site Name:	UNIV OF IL MAIN CAMPUS				
Facility/Site Physical Address:	101 S GREGORY ST				
(City, state, zip code)	URBANA, IL 61801-3070				
Type of Operation:	Lab Materials (Majority gene	rated through research and to	eaching labs)		
Size of Facility:	8900 General Size (Square Fe	et)			
Length of Facility at Location:	1995				
Geographic Coordinates:	40.11219, -88.22061				
Mailing address: (Secondary Address)	2006 Griffith Dr.	2006 Griffith Dr.			
(City, state, zip code)	Champaign, IL	Champaign, IL			
County:					
Facility/Site Identifier:	ILD041544081				
Media Number:	0198270008				
NAICS:

Type of inspection: CEI - Compliance Evaluation Inspection for a Treatment, Storage, Disposal Facility (TSDF).

University of Illinois at Urbana-Champaign EPA Inspection May 17, 2022 All photos taken by Todd Brown (EPA), Inspector, U

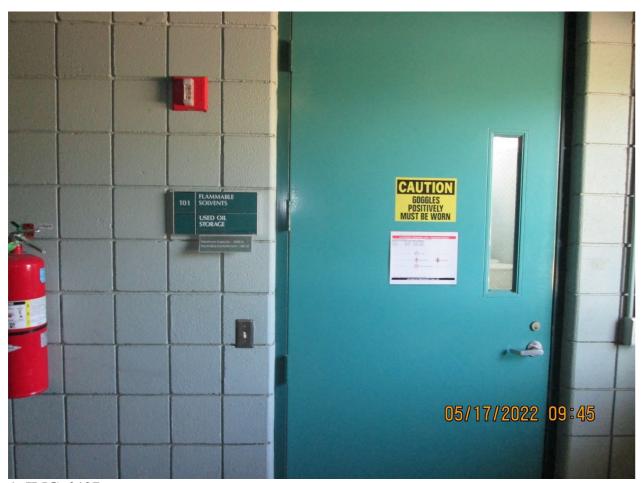
1: IMG 0127

Description: Entrance to Room 101.

Location: Outside Room 101. Solvent Storage Room.

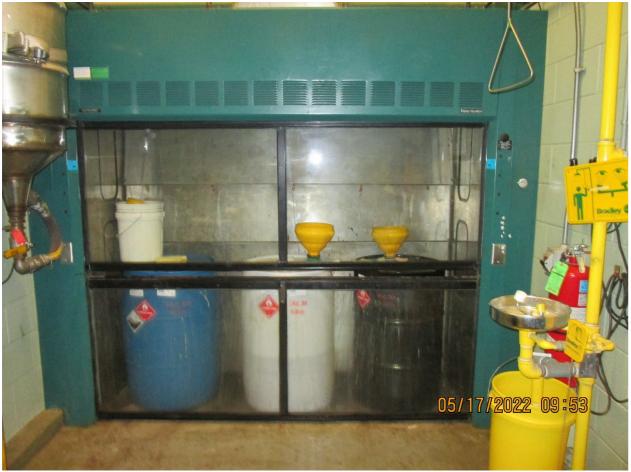
2: IMG 0128

102	Room 102 is adjacent to room 101. In this room incoming solvents are blended into one of the three flammable profiles into 55-gallon drums that are then placed in room 101 (photograph 2). Three active drums were located under the fume hood. All drums were sealed with funnels sitting on top of the drums. Mr. Hill explained room 102 was outfitted with a fire extinguisher, foam suppressant and a heat detection alarm. When asked who is allowed to blend the solvents, Mr. Hill stated that all employees are able to.	No

Description: Three containers of hazardous waste under fume hood. The containers were labeled and closed. The containers held three separate waste streams: (1) halogenated solvents; (2) halogenated/non-halogenated solvents; and (3) mixed non-halogenated solvents.

Location: Room 102. Solvent Bulking Room.

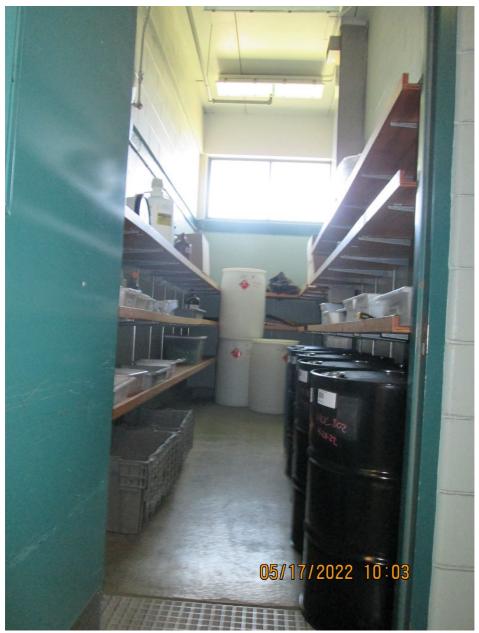
1: IMG_0129

Description: Containers in storage at Room 103. **Location:** Entrance to Room 103. Pesticides Room.

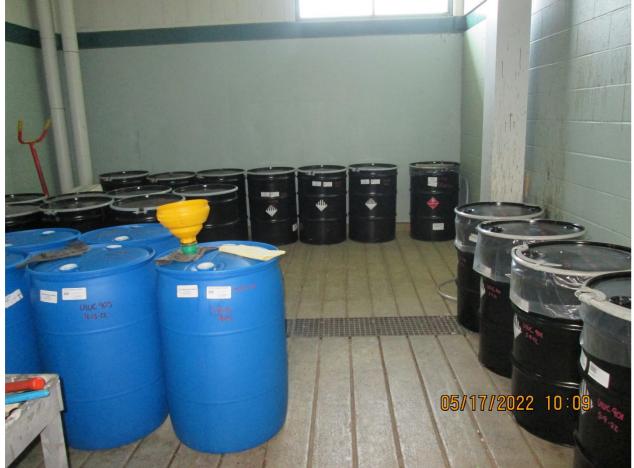
2: IMG_0130

Description: Containers at Room 105.

Location: Room 105. Lab Pack Storage Room.

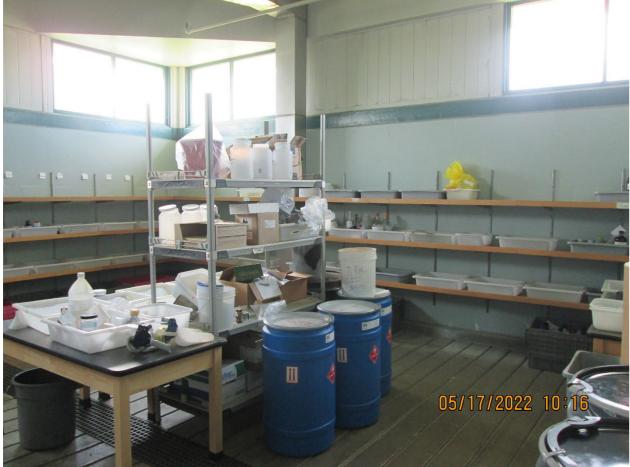
3: IMG 0131

103	The pesticides room is located next to room 102 on the south end of the building. Mr. Hill stated that although the room is labeled pesticides, staff typically handles any pesticides that come in quickly by bagging them and transporting them off-site as soon as possible due to the smell.	No
	At the time of the inspection there were empty drums present in the room and the eastern wall contained bins with various hazardous waste that required clarification on their profiles (photograph 3).	
105	Room 105 is labeled as the lab pack room. Mr. Hill explained that they store debris, silica, and buffer waste in this room. 16 hazardous drums and 4 non-hazardous drums were observed in the room (photograph 4).	No
106	Next, we entered the miscellaneous chemicals room. Mr. Hill referred to the room as the poisons and non-hazardous room. Each wall of the room	No
	contained a different waste chemistry: organics, inorganics, mercury, and in the center of the room were batteries for recycling, photo 5.

Description: View of Room 106. The shelves hold various small-sized containers of hazardous waste.

Location: Room 106. Misc. Chemicals Room.

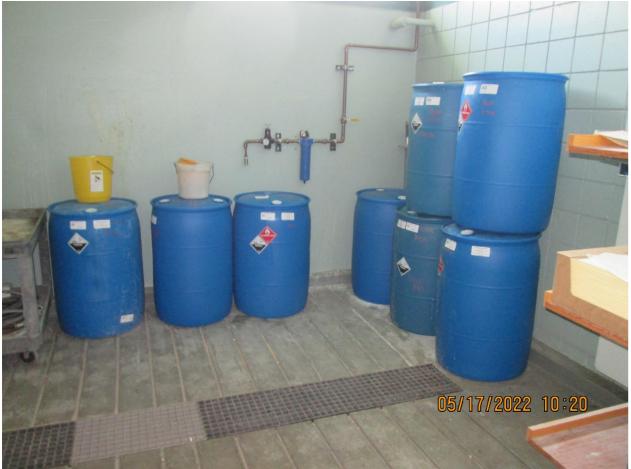
4: IMG_0132

107	Acids and bases were kept in room 107. At the time of the inspection there were 3 full drums of basic waste material drums and 2 non-hazardous drums (photograph 6). Along the wall were several acid shelving units. Located in the room were 3M sorbent pads for spills and an eye wash station was observed directly outside the door.	No
108	The room adjacent to 107 was the air and water reactives room. I observed a dehumidifier running in the corner of the room. Cabinets lined the walls for the distinct types of waste (air, water, corrosives, polymerizables, reducers, mercaptans/sulfides/cyanides, and alkali metals,) (photograph 7). At the time of the inspection, all the cabinets were empty. Mr. Hill commented that Tradebe had come the week prior to pick-up these materials.	No

Description: Containers of caustic waste in Room 107. The two stacked containers were empty.

Location: Room 107. Bases Room.

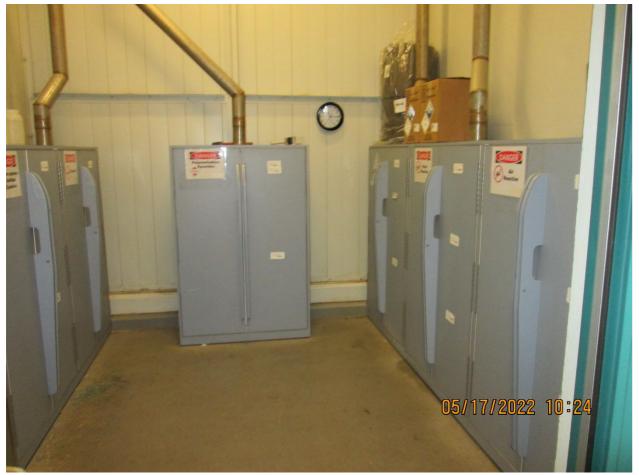
5: IMG_0133

Description: Cabinets in Room 108. The cabinets were labeled as follows: (1) Air Reactive; (2) Water Reactive; (3) Polymerizable Explosives; (4) Reducers; (5) Mercaptans, Sulfides, Cyanides; and (6) Alkali Metals.

Location: Room 108. Reactives Room.

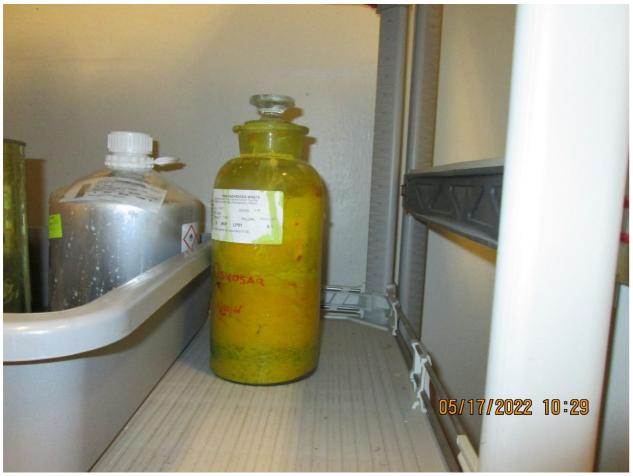
6: IMG_0134

109	Room 109 is dedicated to gas cylinders and	Yes - containers
	explosives. At the time of the inspection, we	stored for over a
	observed one shelving unit with waste material that	year period.
	was past a year in storage (photographs 8 & 9). We	
	asked Mr. Hill about the two items, and he stated	
	that both waste containers were being treated for	
	stabilization. He commented that the Tradebe	
	chemist would be coming to review items for the	
	next shipment in a couple of weeks. Based on the	
	chemist's assessment the items would either be	
	considered stable for transport or left to continue	
	their stabilization.	
	To the side of the stabilization shelving were boxed	
	aerosols. The box was labeled hazardous waste and	
	Mr. Hill stated that they would be shipped as such	
	despite aerosols being recently classified as	
	universal waste in Illinois.	
110	Room 110 was labeled oxidizers and three	No
	containers were observed in the room.

Description: Container of waste on shelf in Room 109. The labeling stated it was "non-hazardous" (see photograph 9). However, this material had been stored since it least March 25, 2021. According to Mr. Landon Hill, Regulatory Compliance Manager, the material was not safe to transport. The university has been slowly adding water to saturate the solids. The material came from a wood engineering laboratory.

Location: Room 109. Explosives/Gas Cylinder Room.

Mr. Hill indicated he would fix the labeling on the drums immediately and stated that the two containers of concern were in storage still due to stabilization concerns and would be shipped immediately once deemed stable for transport by Tradebe.

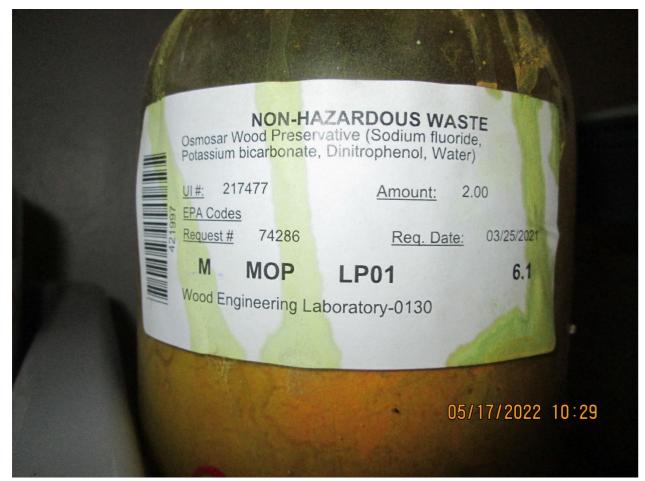
7: IMG_0135

Description: Label on bottle in photograph 8.

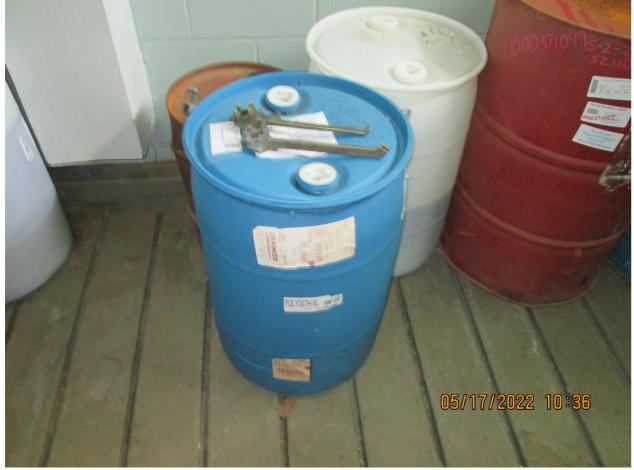
8: IMG_0136

I reviewed two non-hazardous waste streams identified during the facility tour, UI 219033 and UI 211999. I asked Mr. Hill to provide the documents for the determination. One was selected from room 111 in the PCB/Dioxin room, photo 10 & 11.

Description: Container labeled "non-hazardous" waste. See photograph 11 for label.

Location: Room 111. PCB/Dioxin Room.

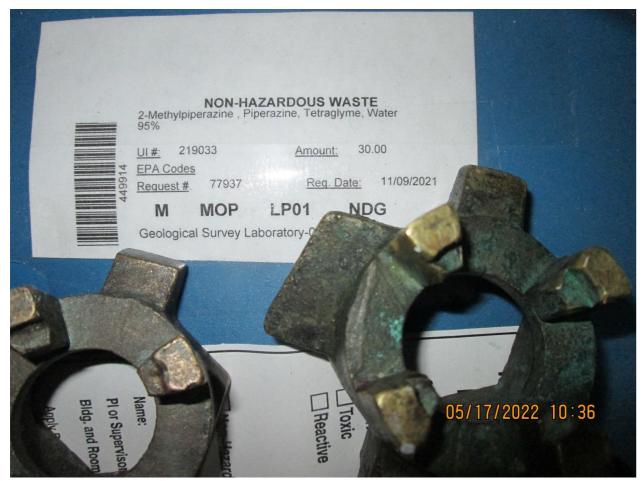
9: IMG_0137

Description: Label on container in photograph 10.

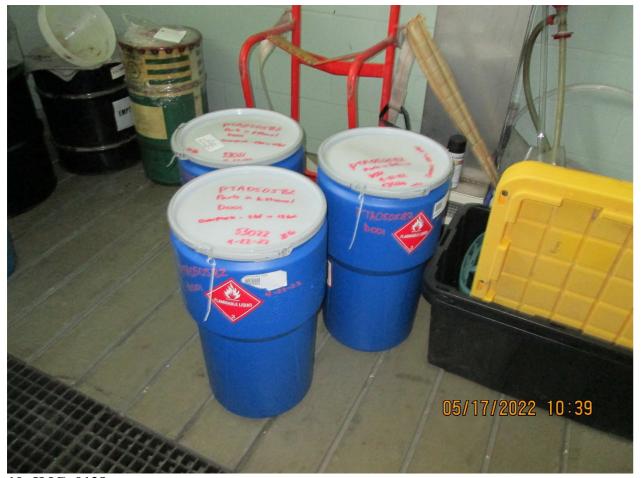
10: IMG_0138

111	Room 111 was labeled for PCB and used oil. Mr. Hill	Yes - Hazardous
	stated that the SMSF no longer collected and stored	waste drums not
	PCB waste. At the time of the inspection 3 small	properly labeled.
	drums were observed without hazardous waste	
	labels (photograph 12).	
	Mr. Hill stated that the drums had recently come in

and had been accepted under the generic waste labeling and that he had not been able to print the labels yet but that they were in the system. All three drums were labeled with the profile written on top of the drum lid, photo 13. Beyond the three unlabeled drums there were fifteen additional drums and containers in the room. The remaining waste containers were labeled correctly.	
112	Area 112 located in the center of the SMSF is considered a catch-all with storage of non-hazardous waste and hazardous waste. Drums were lined up in the northeastern area of the room. The area appeared clean, and all drums were appropriately sealed.	No
126	Room 125 was in the northern section of the building. This room contained radioactive waste. Material in this room is boxed or in containers and stored until the radioactive half-life is met.	No
127	Room 126 is located next to room 125 and holds sharps and other medical waste. Mr. Hill stated that Stericycle comes roughly 2 times per week to pick-up sharps and biomedical waste.	No

Description: Three containers of mice in ignitable liquid. The marking on top of containers included the D001 waste code. However, the containers were not labeled with the words, "Hazardous Waste." See photograph 13 for markings.

Location: Room 111. PCB/Dioxin Room.

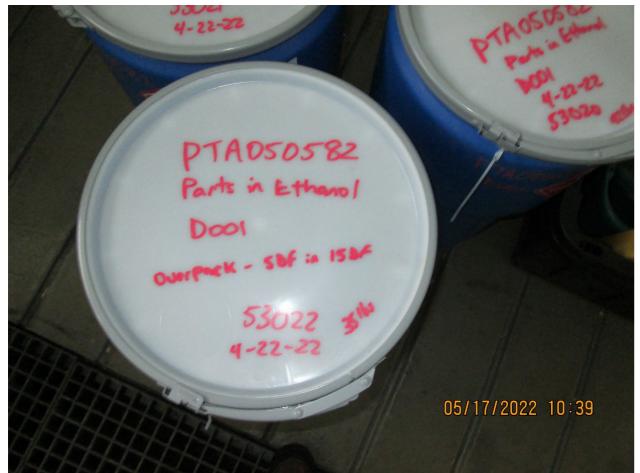
11: IMG_0139

Description: Marking on containers in photograph 12.

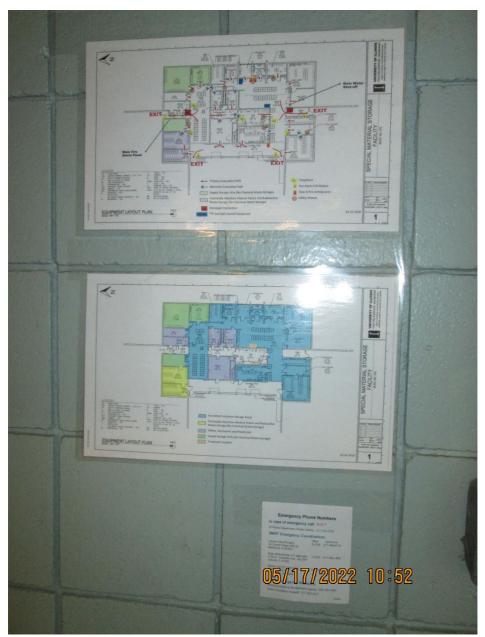
12: IMG_0140

During the walk through I noted evacuation routes and emergency response numbers located by many of the doors in the facility (photographs 14 & 15). A few contacts had retired and when asked, Mr. Hill said they were updating the records.

Description: Posting on wall next to facility exit. **Location:** West wall near door to Room 127.

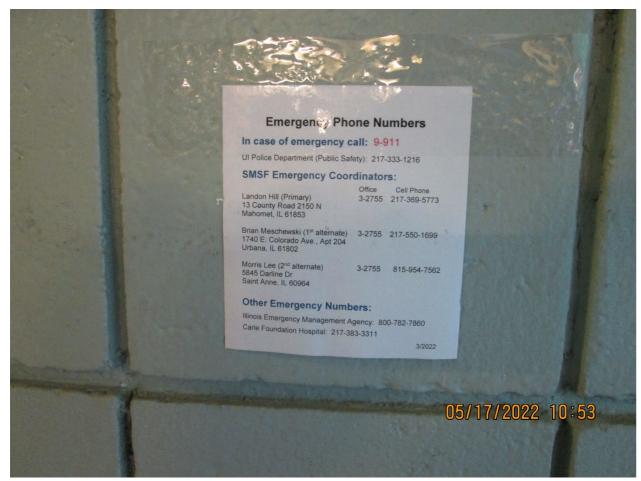
13: IMG_0141

Description: Posting on wall next to facility exit. **Location:** West wall near door to Room 127.
